The
San Francisco Earthquake and Fire

A BRIEF HISTORY OF THE DISASTER

A Presentation of Facts and Resulting Phenomena, with Special
Reference to the Efficiency of Building Materials
Lessons of the Disaster

A. L. A. HIMMELWRIGHT, C.E.

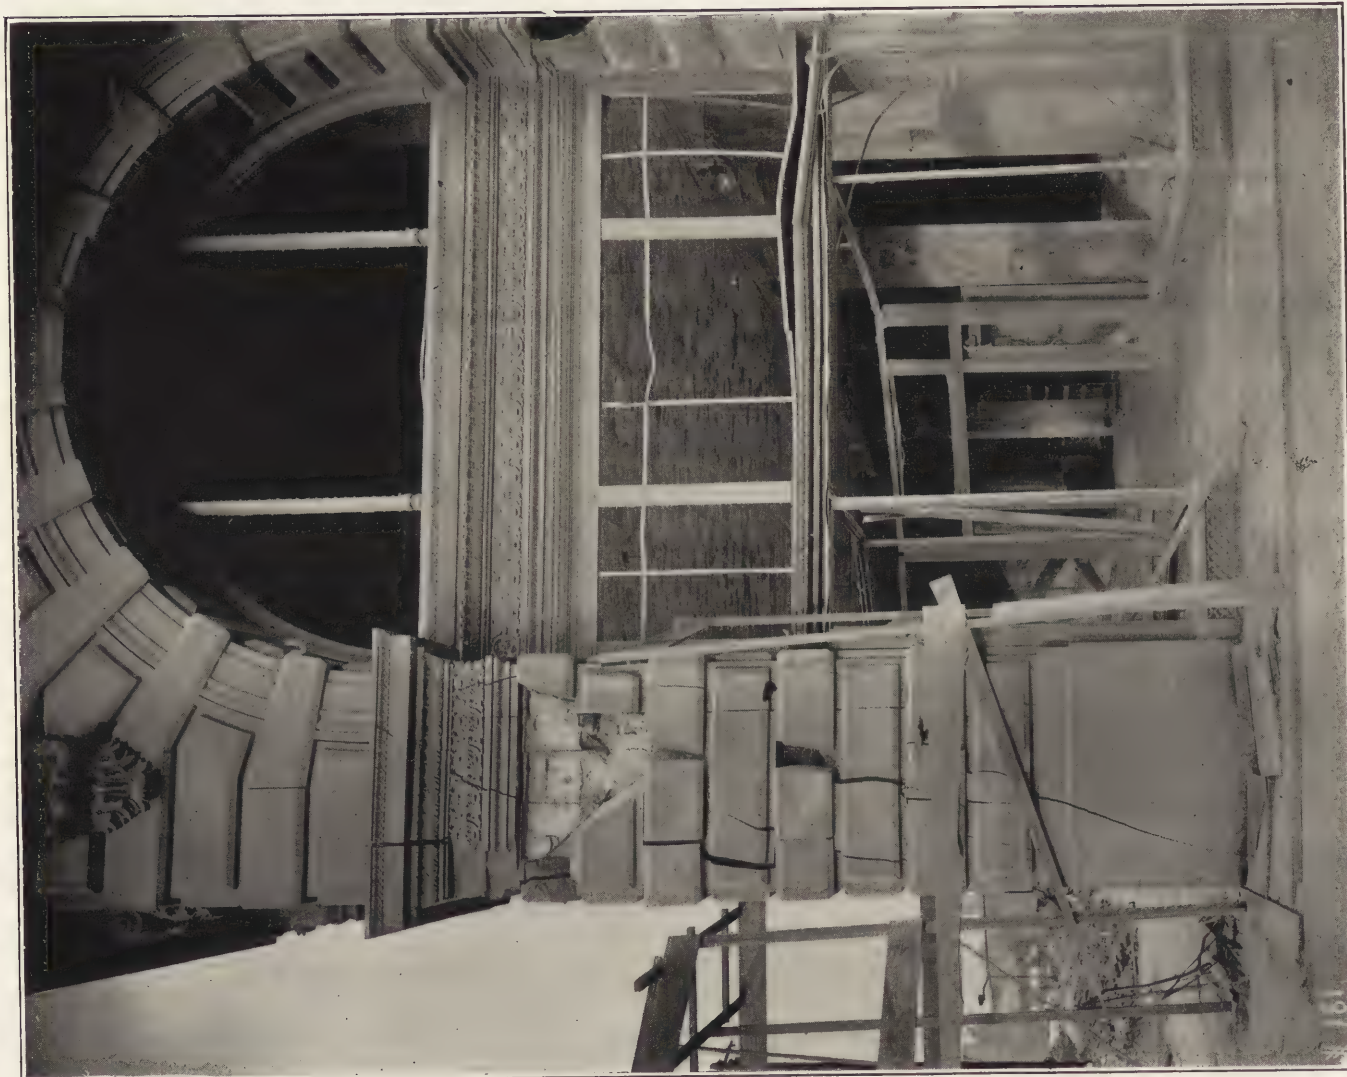
JAMES FLOOD BUILDING. Showing the earthquake damage to the northwest corner pier at the first story level.

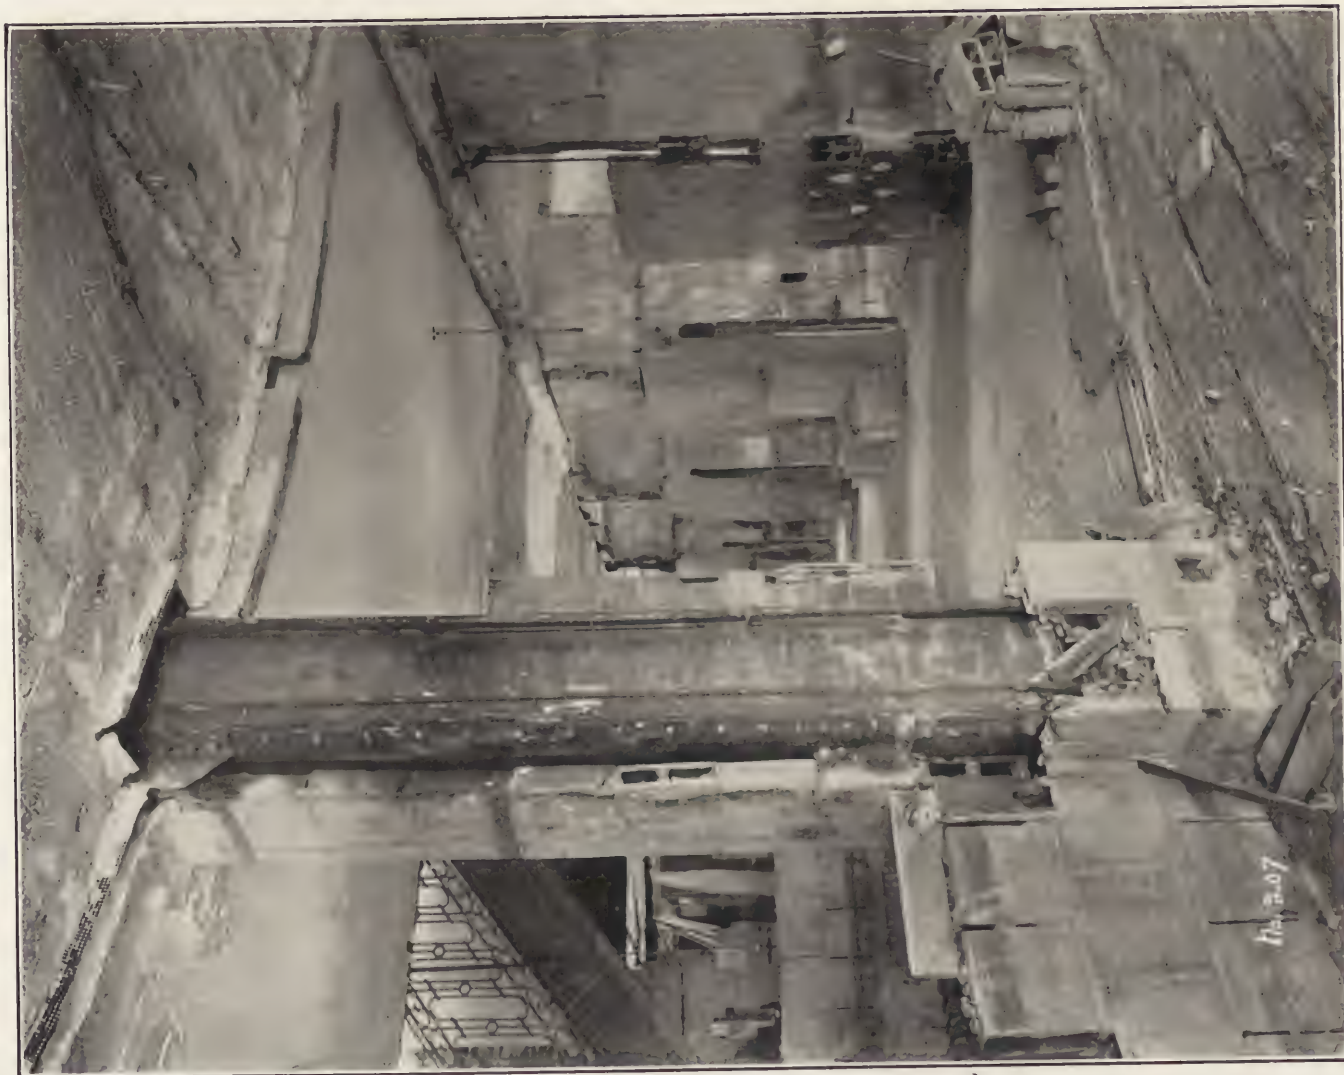
FLOOD BUILDING. Fourth Story, southwest corner. Showing typical damage to the 4" hollow tile partitions that were built solidly from the top of the fire-proof flooring through the Roebbling wire lath ceiling to the under side of the hollow tile arches above. Under these conditions, when the partitions expand from heatings there is a tendency to buckle or deflect, which frequently causes failure. The blocks over the door openings have generally been forced down into the opening, and have dropped out from this cause. Some of the partitions that remain standing are weak and in a tottering condition. This illustration shows also the brick-filled column inclosed by 3" hollow tile blocks. This is an improvement over the ordinary method, but could be rendered still more efficient by filling the space between the hollow tile protection and the steel member solidly with cement mortar, and by providing a separate enclosure for pipes.

The advantage of carrying hollow tile partition blocks only to the wire lath and plastered ceiling, instead of through the ceiling against the rigid fire-proof floors or beams above, is clearly shown in the top story, where the partitions remain in better condition than in any other part of the building. When hollow block partitions are erected between rigid incombustible surfaces, there is no opportunity for the material to expand under heat; consequently, when expansion takes place in a fire, the blocks over door openings are forced down into the openings and fall out. The expansion also causes an immediate tendency to buckle or deflect the partitions, which in many cases causes failures sooner than would otherwise be the case.

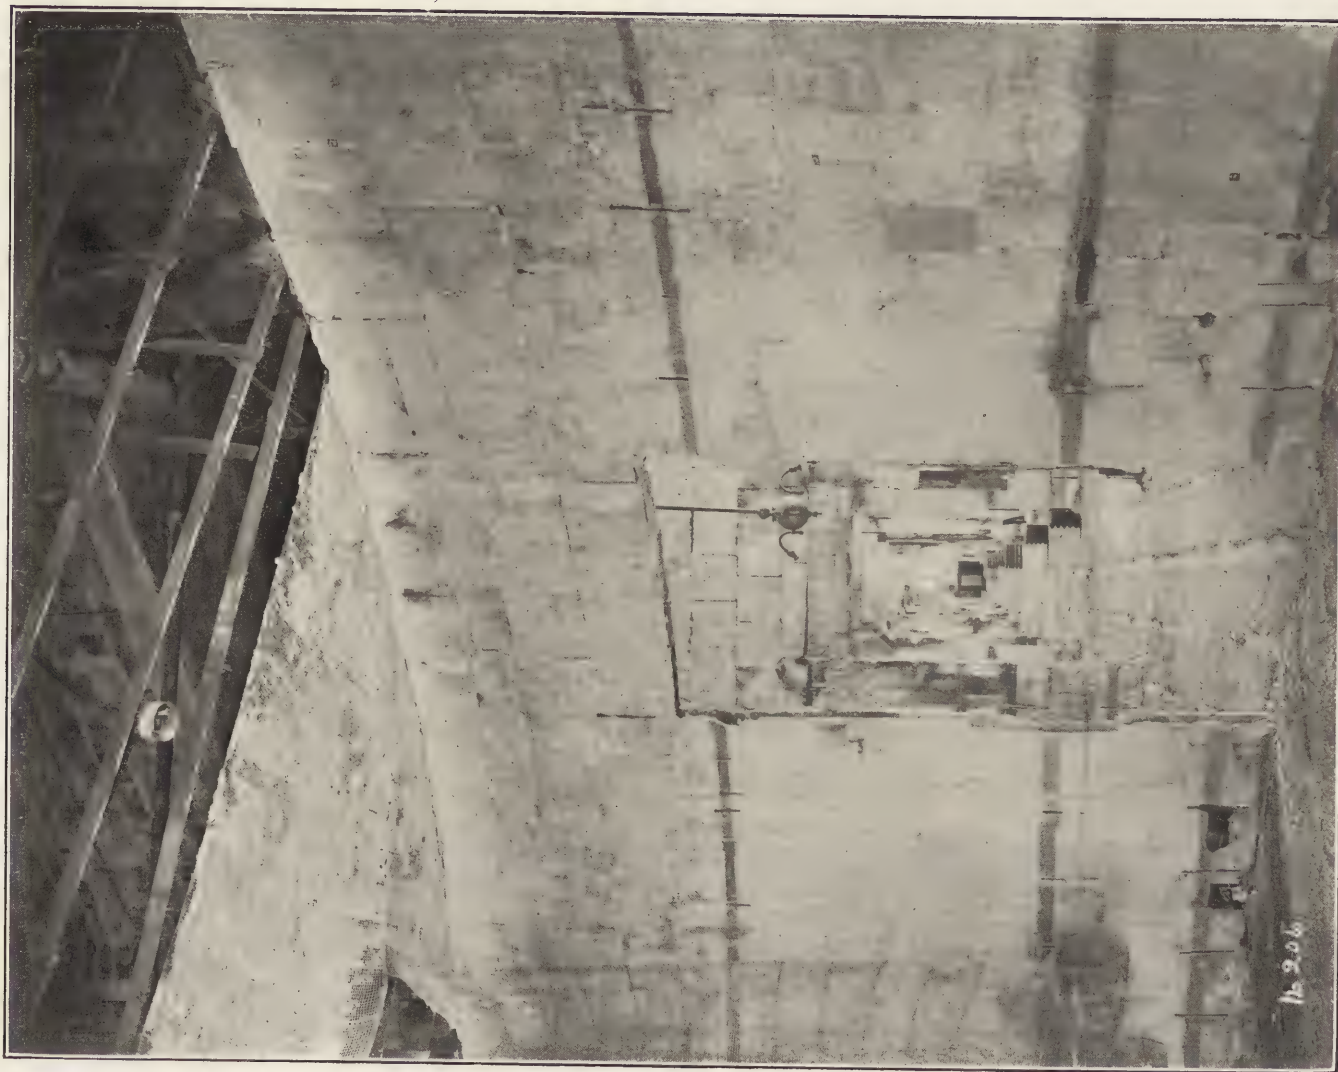
FLOOD BUILDING. Tenth Story. Showing the typical condition of the 4" hollow tile partitions that were built from the top of the fire-proof flooring to the under side of the Roebbing wire lath suspended ceiling. The partitions in this story were in much better condition than in the lower stories because the wire lath ceiling acted as a cushion and permitted them to expand when heated. The blocks over the door openings remain in place. This view is taken looking through a row of offices. The loose sheets of wire lath shown in the view have dropped away from the supports, on account of being laced to them with copper wire, which is much weaker for this purpose than steel wire.

the building, is due to the fact that the lath was laced to the ceiling supports with No. 16 B. & S. gauge copper wire. Had a mild steel wire (which fuses and weakens at a much higher temperature) been employed, these portions of the ceiling would no doubt have remained in place, and the damage to the hollow tile blocks above would have been prevented.

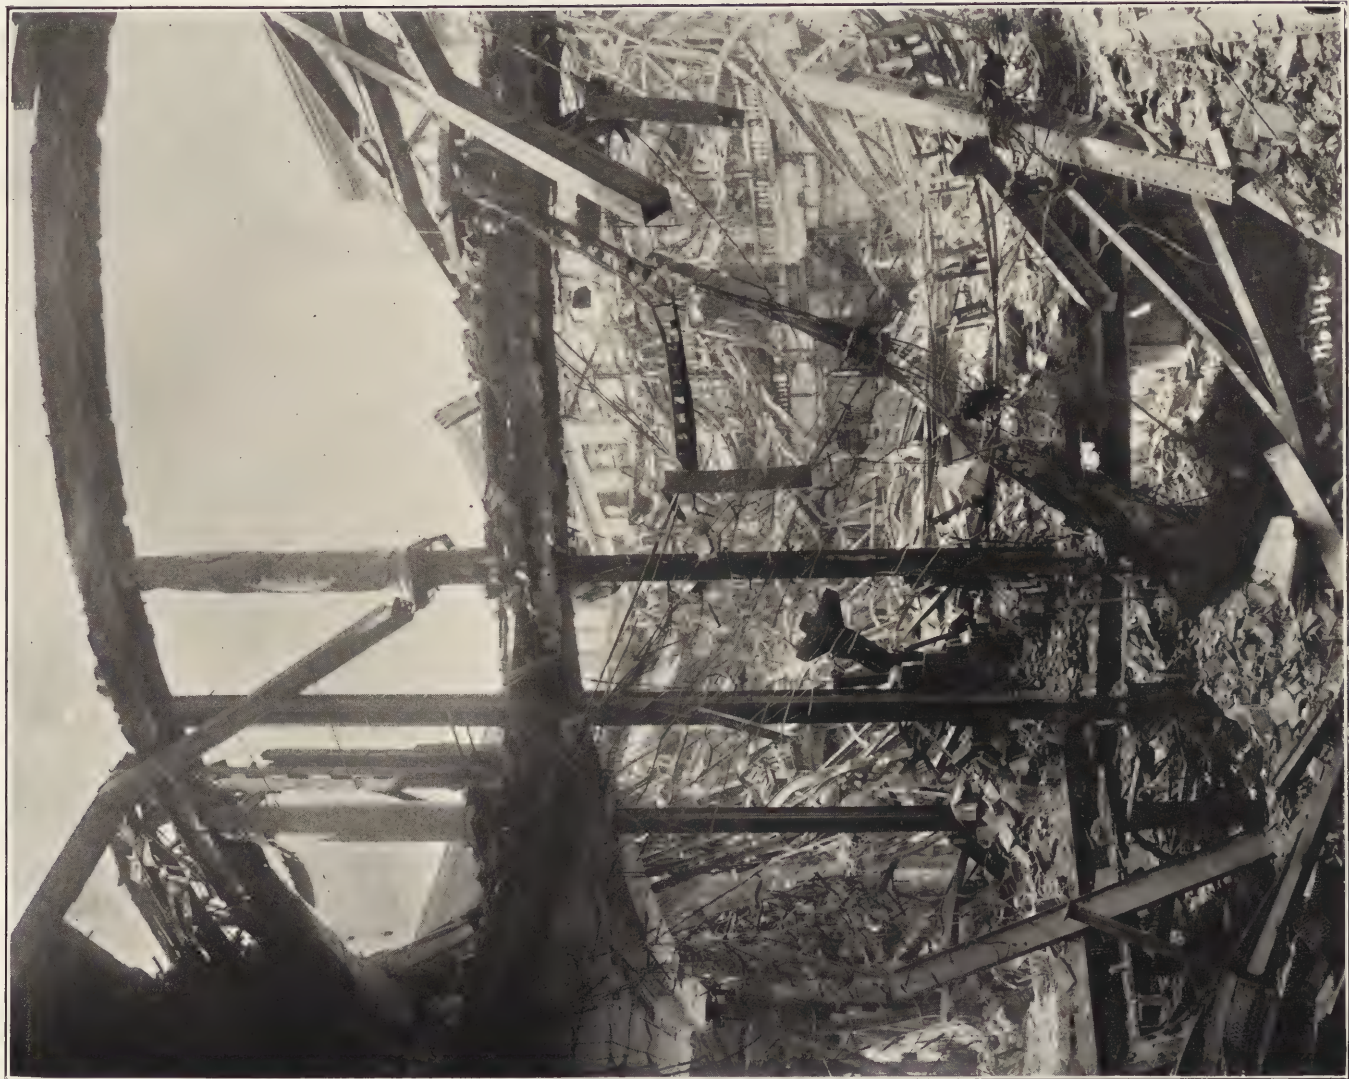
There are a large number of columns that have buckled from the heat in the basement story adjacent to the collapsed sections. There are also numerous buckled and deflected columns in different portions of the building that show evidences of having been heated to a red heat after the hollow tile column protection had failed. In some cases these columns have doubled over on themselves and present very curious, though interesting, studies of the manner in which steel fails when highly heated. It is noticeable that wherever the steel work is considerably warped, the hollow tile blocks have fallen out. The light steel, wire lath and plaster ceiling construction, with the plaster still adhering to it, is lying about over the floors in all manner of grotesque shapes and clinging in sheets to portions of the steel framing in places.

PARROTT BUILDING. First Story. Looking toward the central light court from the east. Showing wreckage of steel, hollow tile floor arches, partitions and column covering, and wire lath and plaster ceilings, much of which fell into the open space of the light court. Note the badly deflected basement column in the lower left-hand corner.

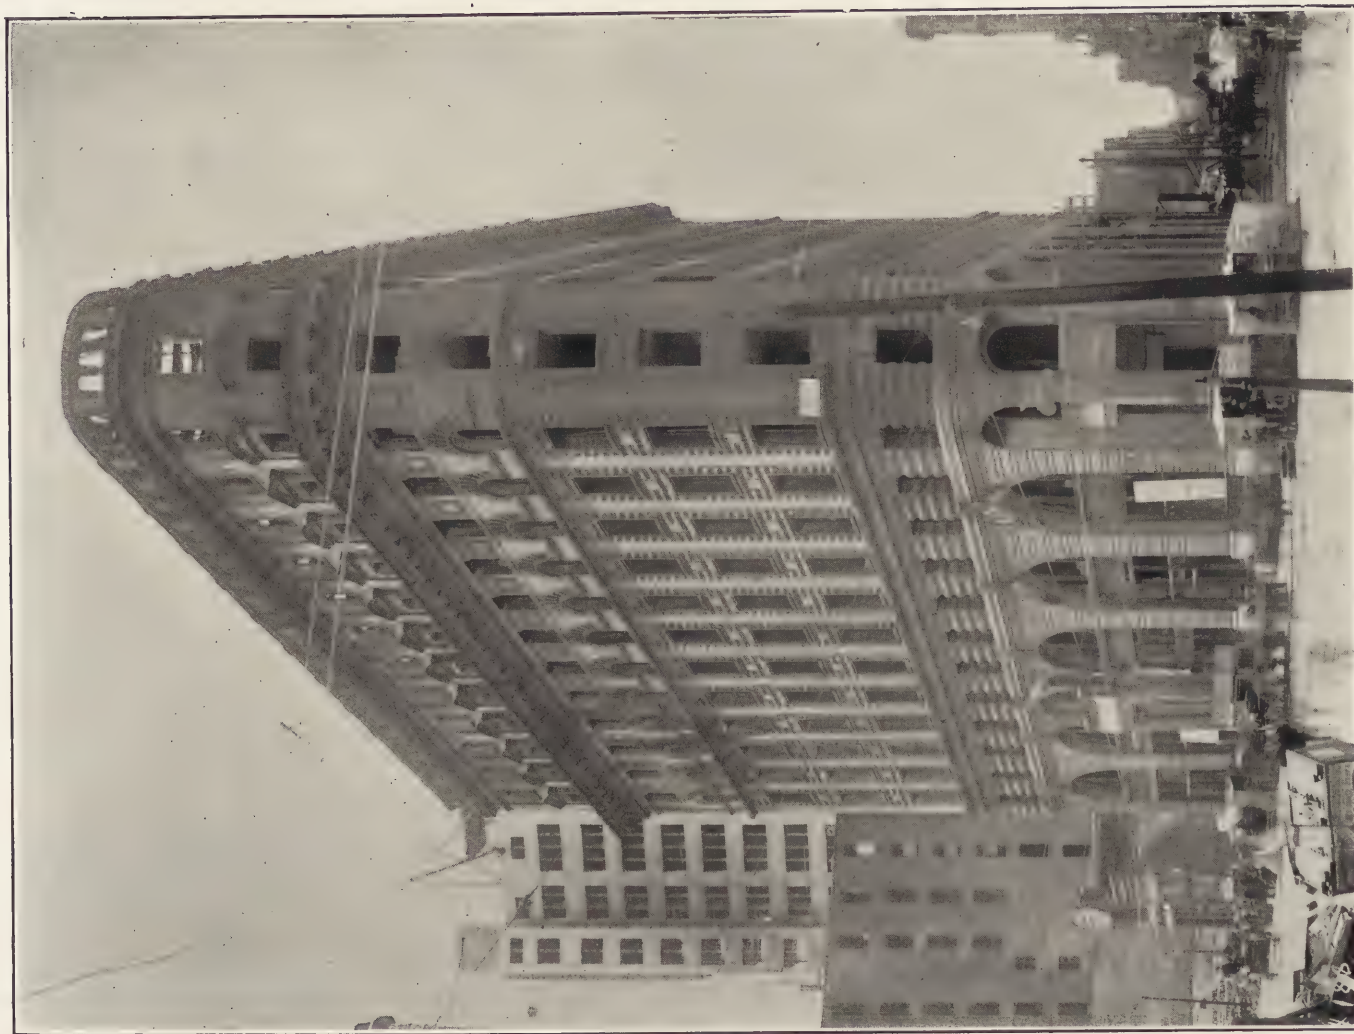
CROCKER BUILDING. Market, Post and Montgomery Streets. The façades are of granite for the first and second stories and buff terra cotta above. With the exception of the second-story window heads on the Post Street side, which are slightly spalled, the façades are comparatively little injured by the fire; but the earthquake caused considerable damage to the walls in the upper stories. The roof, of wood construction, was consumed, causing the collapse of the light steel framing supporting it, which fell to the eleventh floor and broke down some of the hollow tile floor arches. A column on the ninth floor buckled on account of the failure of the hollow tile protection. The soffits of the hollow tile floor arches are off over considerable areas, exposing the cellular spaces. Some of the arches were broken out by falling safes. The hollow tile partitions are badly wrecked throughout the building. The hollow tile column protection and exterior wall furring are greatly damaged, and have fallen away in many places.

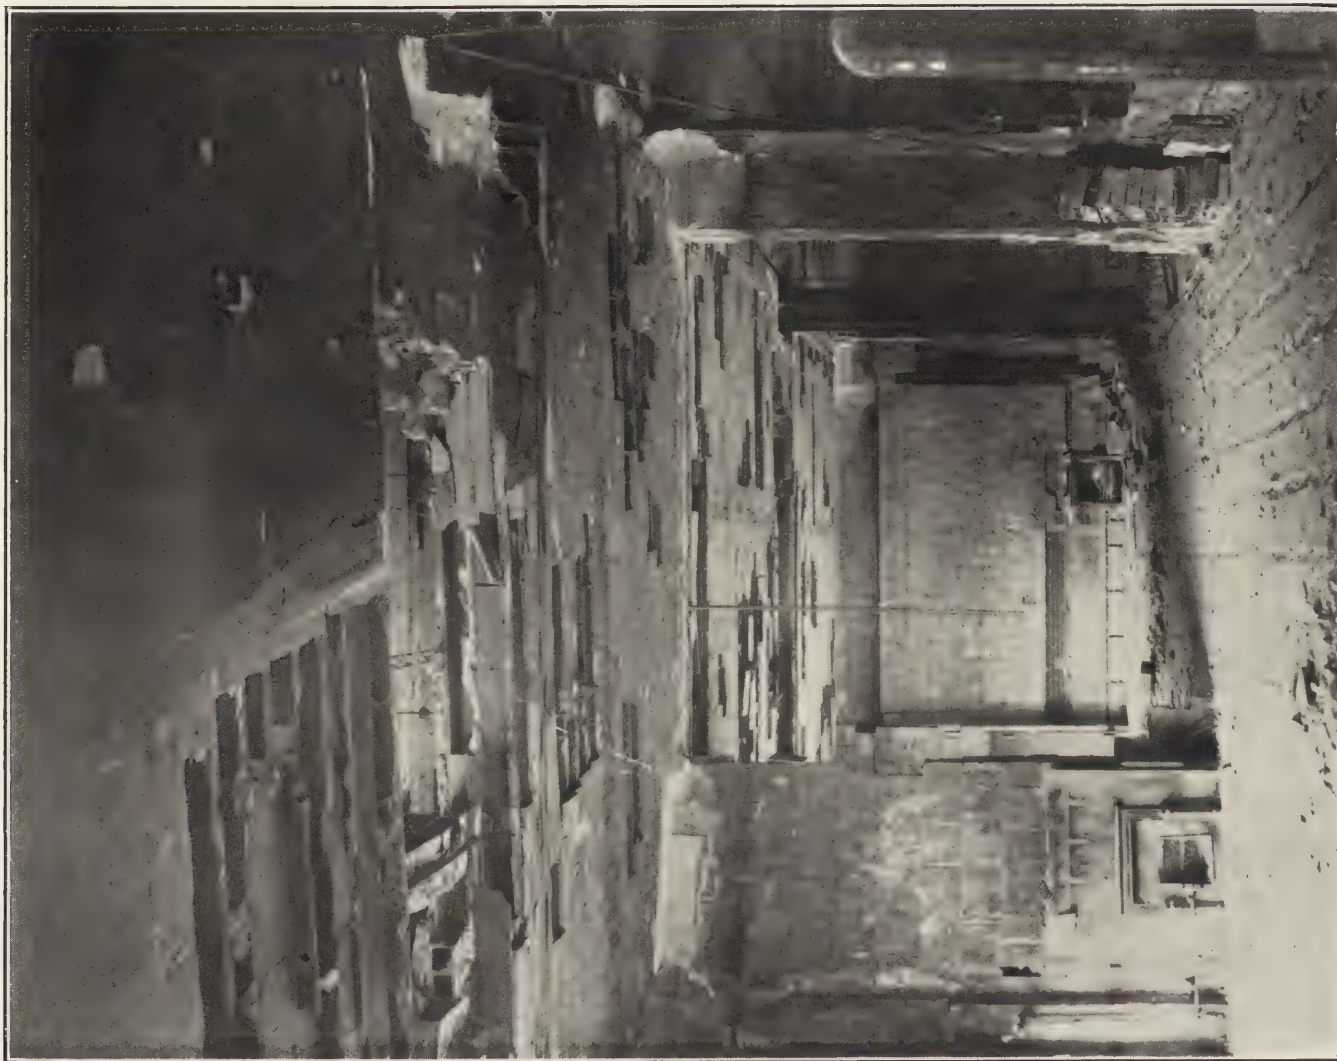
The hollow tile partitions are badly wrecked, having fallen down throughout the building. The exterior wall furring is off in many places and cracked and loose where it still adheres to the walls. The hollow tile column covering is greatly damaged and has fallen away in a number of places.

CROCKER BUILDING. Second Story. Typical view showing damage to the hollow tile floor arches, column covering and partitions. The *débris* had been removed from the floor when the photograph was taken.

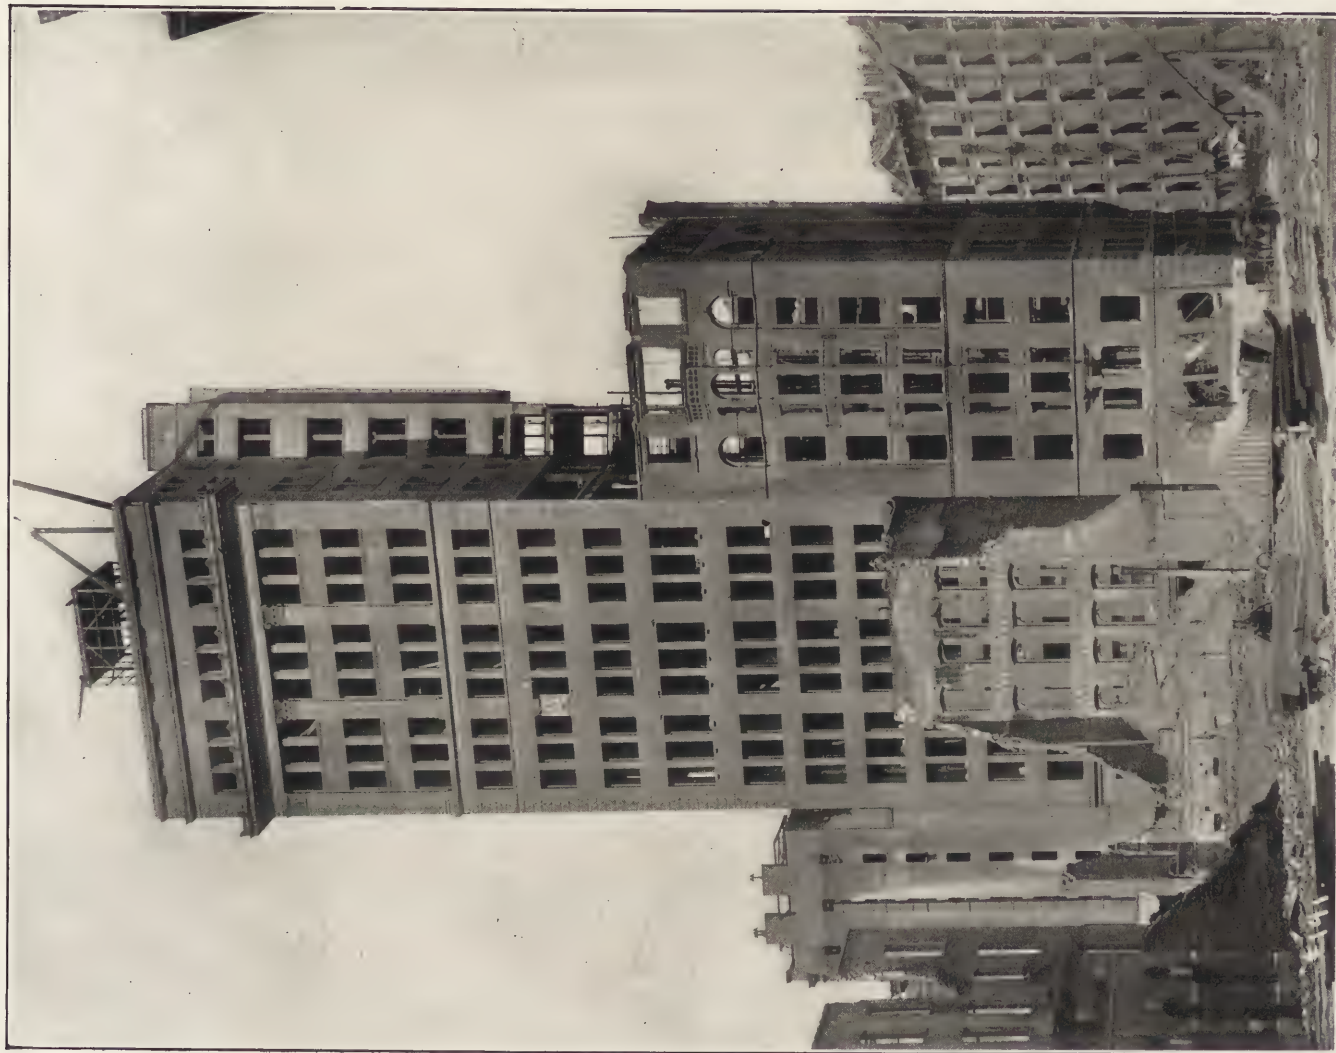
CHRONICLE BUILDING AND ANNEX. Junction Kearny and Market Streets. The original building is on the right. The brown stone of the first story is badly damaged, but the pressed red brick above is uninjured. Some of the terra cotta ornamentation around the brickwork is spalled. The burning of the wood roof no doubt started the precipitation of 19 linotype machines in the top story on the Kearny Street side, which fell to the basement, carrying with them successive tiers of steel framing and hollow tile arches underneath. In the rest of the building, the hollow tile arches are damaged in many places; the 4" hollow tile partitions are badly wrecked; and the 3" hollow tile column protection is damaged, and has fallen away in spots.

The façade of the new annex, consisting of gray sand-stone and terra cotta for the first story and pressed red brick and terra cotta above, sustained little fire damage, but is considerably injured by characteristic X earthquake cracks from the seventh to the thirteenth stories. The annex was in the course of construction, and was subjected to a moderate fire only from the combustion of scaffolding lumber, wood trim, etc. The soffits of a number of the heavy 16" flat hollow tile floor arch blocks were spalled off, and the hollow tile partitions and column covering were damaged so that considerable sections will require rebuilding. The steel frame is uninjured, excepting one column between the two buildings, which was unprotected at the time of the fire.

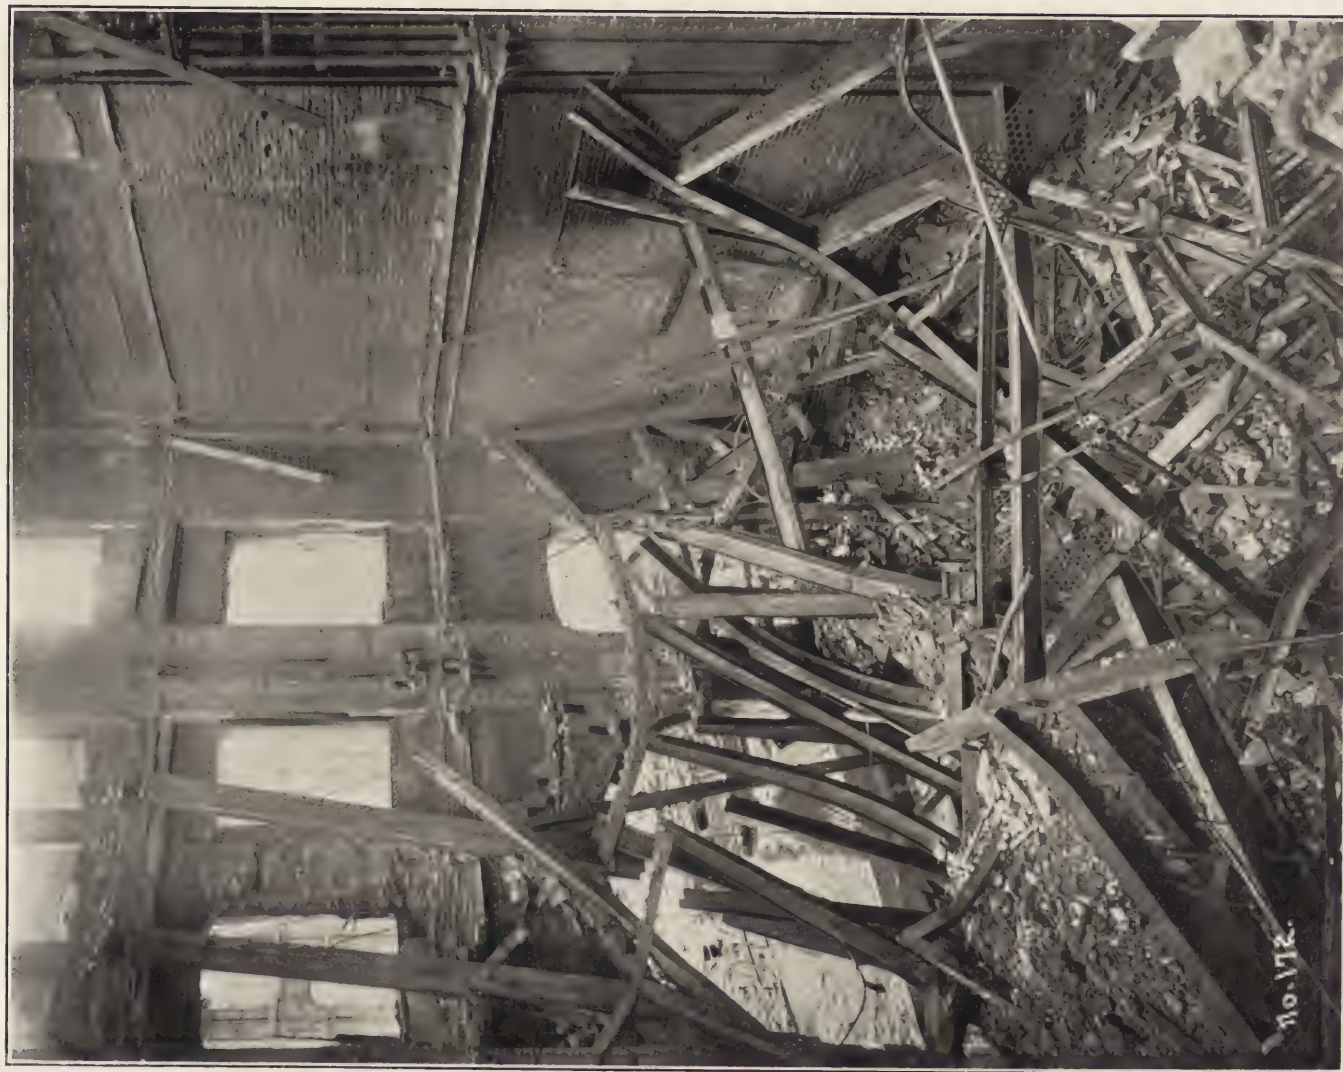
The manner in which the steel work was broken down presents some interesting features. In several instances where the floors of bay windows were supported by double beams projecting beyond the walls the double beams have broken at the separator holes in line with the inside surface of the wall. In the top story, a cast-iron wall column was broken about midway of the height of the story, the broken top with the beam and girder connections having dropped down so that the beams which supported the floor above now rest on the top of the broken column. The steel frame in the portion of the building that did not collapse is in fair condition.

CHRONICLE BUILDING. Showing the interior on the Kearny Street side, which collapsed from the roof, the wreckage filling the basement to the ground-floor level. The columns are of cast iron, with steel framing supporting the floors. Two double beams supporting bay window projections on the left-hand side have broken off at the separator holes and remain hanging in a vertical position. The fire-proof floors were built of the old-style single-cell 9" hollow tile blocks. A wood roof and 19 linotype machines in the top story are responsible for this damage.

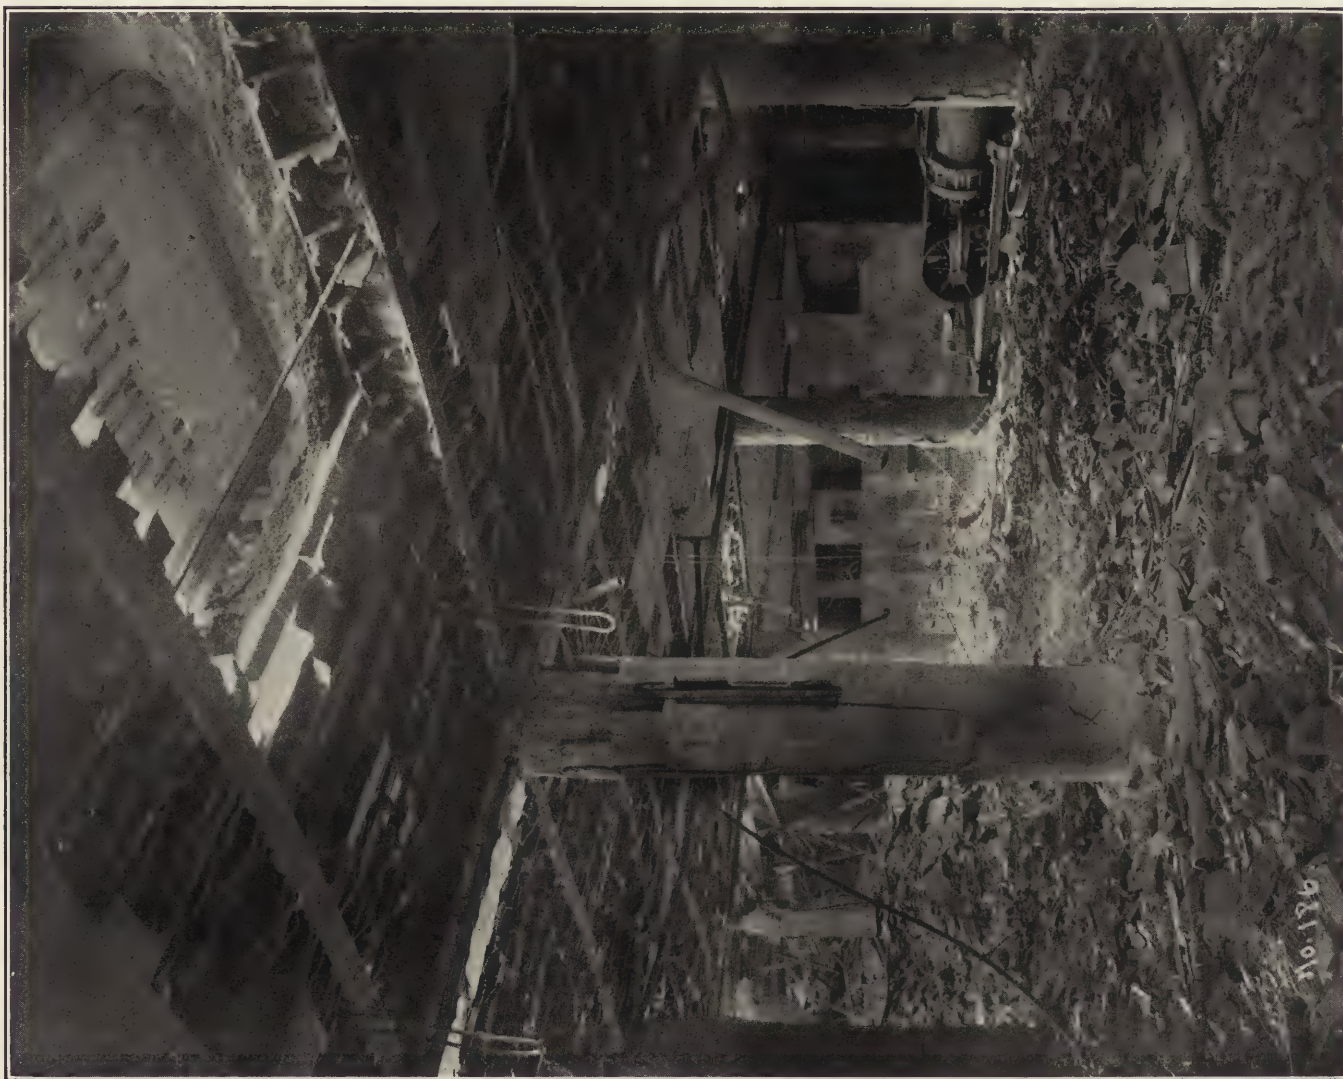
SPRING VALLEY BUILDING. Basement Story. Showing the typical damage in this story to the hollow tile floors and column protection. The openings through the ceilings show the total failure by fire of the floor arches at those points. At the extreme left is shown a portion of a large section of the building that collapsed. The hollow tile and plaster *débris* on the floor averages 8" in depth.

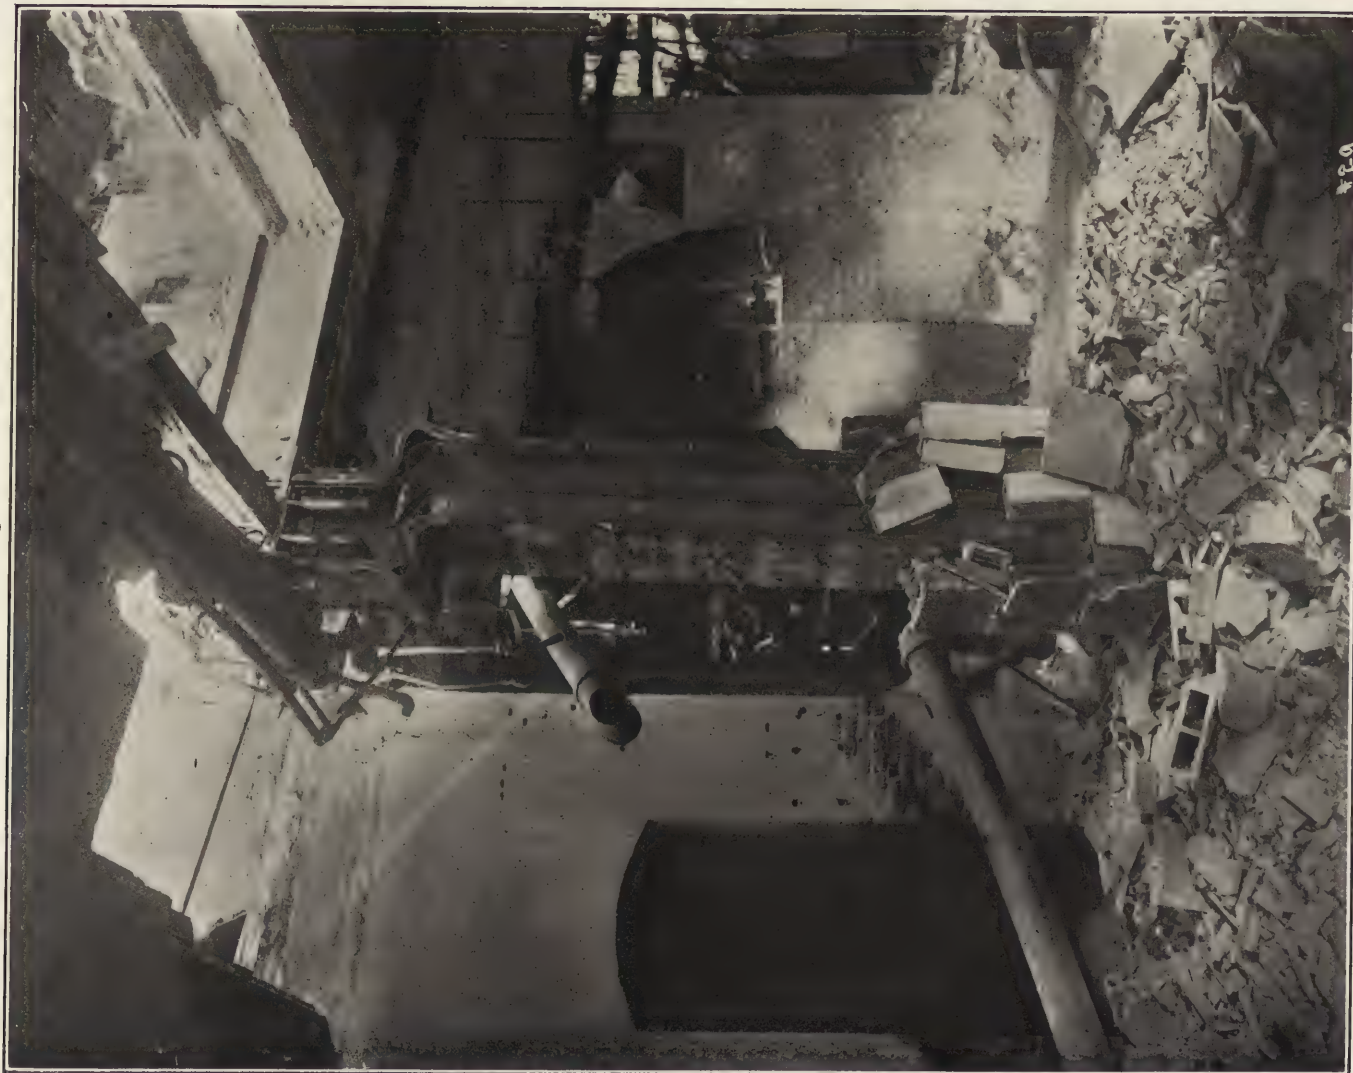
MILLS BUILDING. Basement Story. Showing the failure of the hollow tile column protection and a buckled column; also openings in the floor spans adjoining the buckled column. The hollow tile floor arches fell out when the steel beams supported by the buckled column settled. The piping near the ceiling line adjacent to the column was probably, in part, responsible for the beginning of this damage.

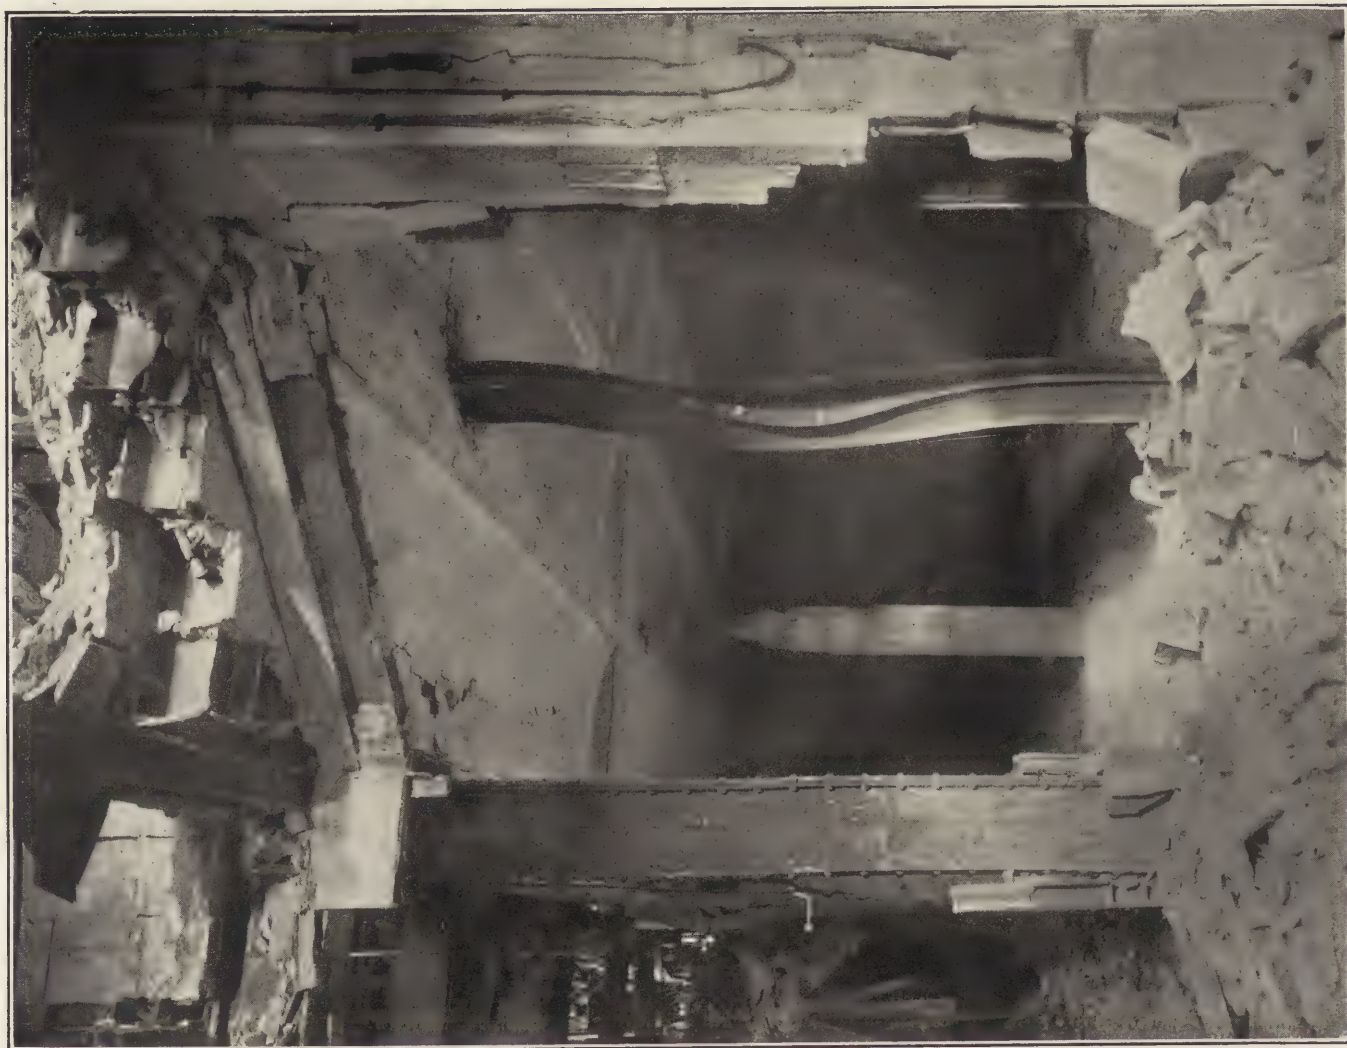
MILLS BUILDING. Basement Story. Showing the damage to the hollow tile protection of the columns. The deflected columns were caused by the total failure of the protection.

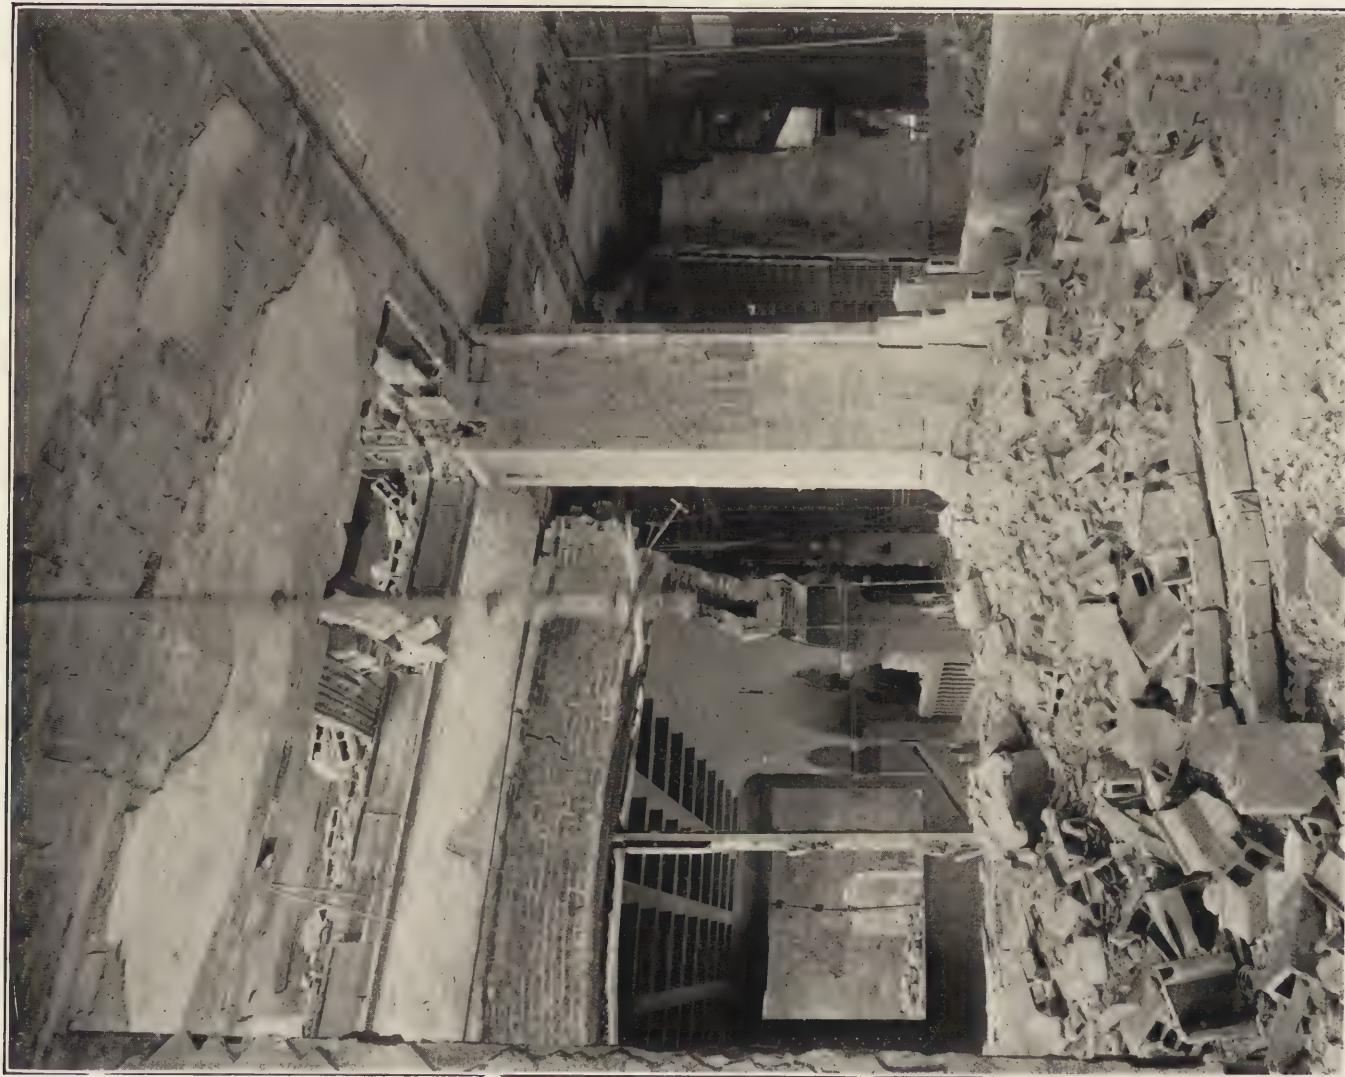
The hollow tile floors have been considerably damaged throughout. At numerous places there are large areas where the soffit members of the floor blocks have failed and fallen away, exposing the cellular spaces. Several safes have fallen from the upper stories and broken through successive floors to the basement.

MILLS BUILDING. Second Story. Showing the damage caused by a safe falling from one of the upper stories. The safe in the pile of *débris* rests on a beam in line with the column.

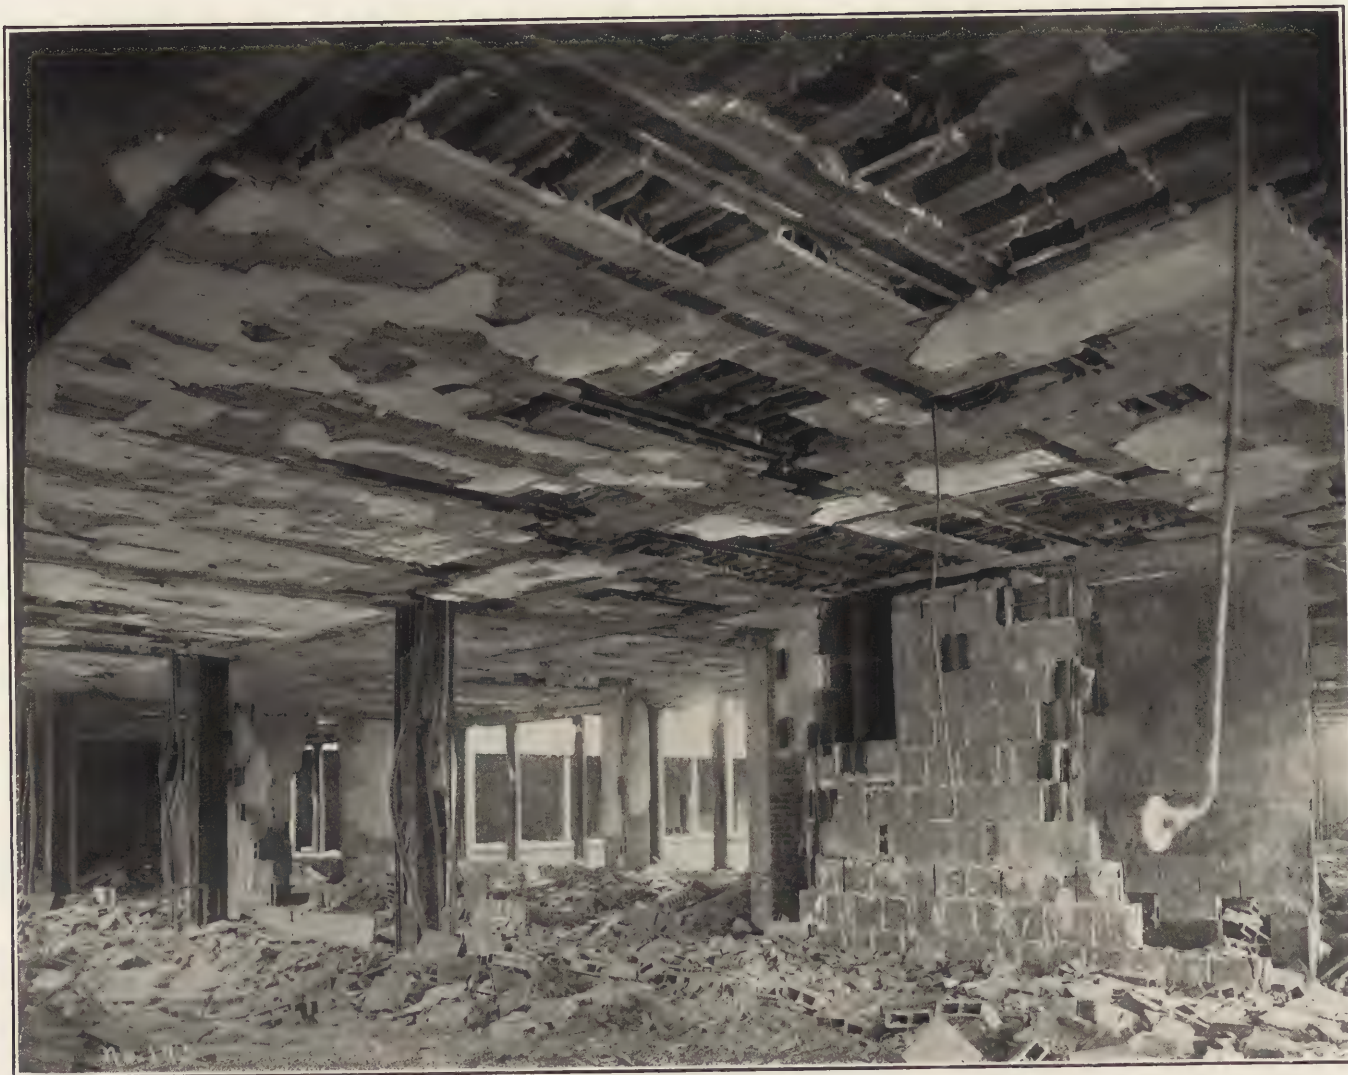
The hollow tile partitions are completely wrecked in many places, and where still standing they are so weak that they will have to be rebuilt. The column protection, in many cases being a part of the partition, was badly disrupted when the partitions failed. Bulging pipes that followed the lines of the columns also contributed largely to the failure of the column protection.

MILLS BUILDING. Fourth Story. Looking east toward the central light court. Showing typical damage to the hollow tile floors, partitions and column covering in this building. The bulging of the pipes within the column covering doubtless caused much of the damage to the protection.

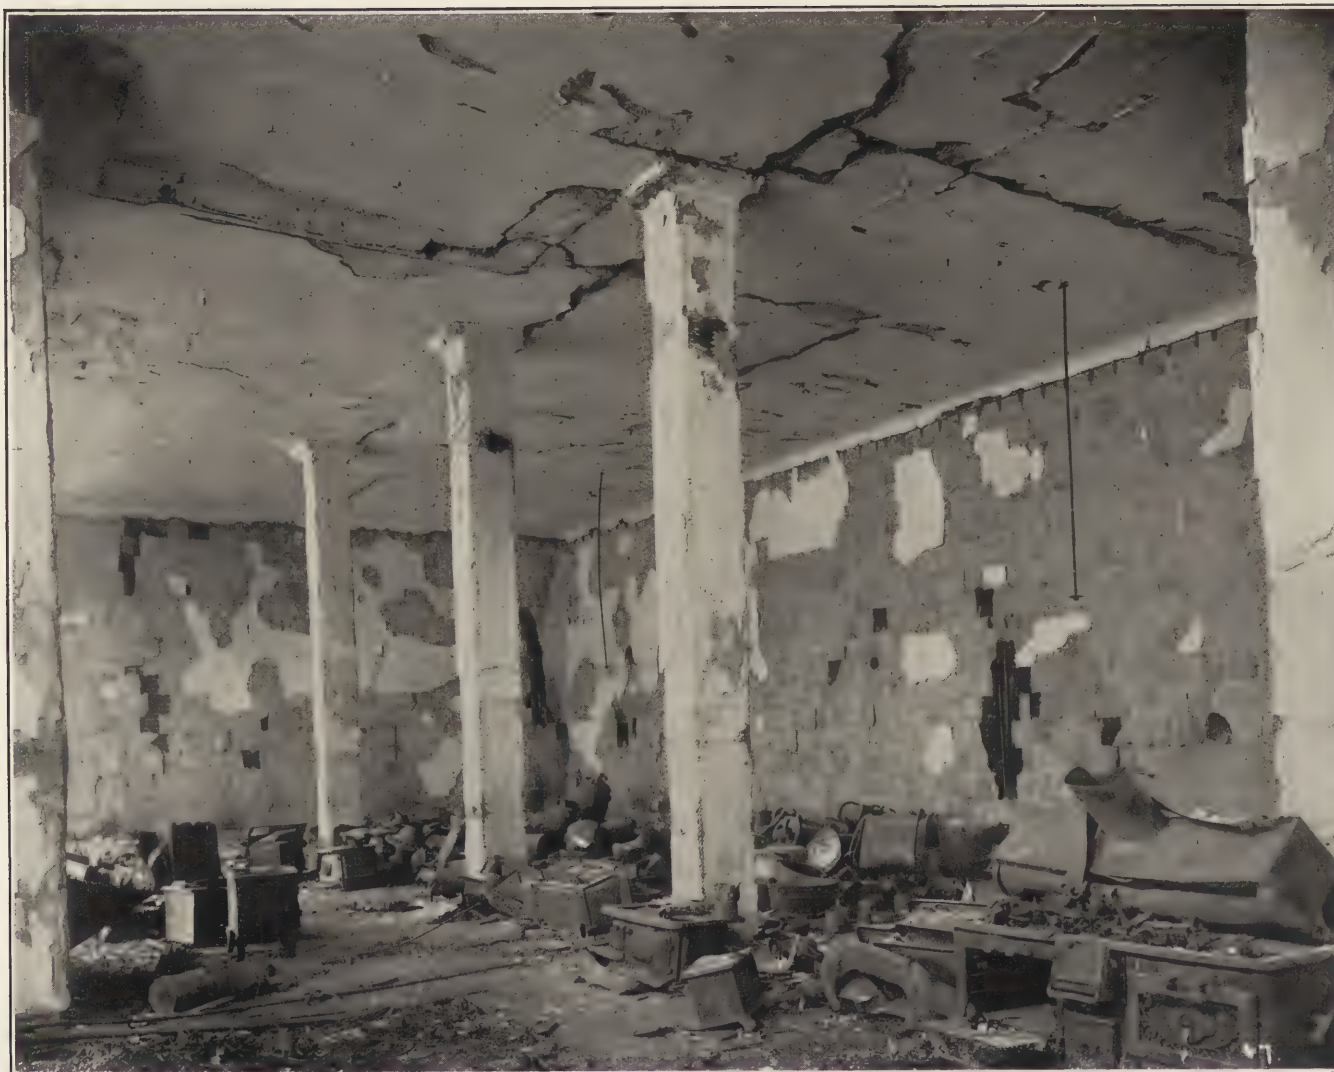
YOUNG BUILDING. First Story. Showing the damage to the expanded metal lath and plaster column protection, and the earthquake cracks in the flat expanded metal lath and plaster ceiling. The pipes in the wall chases have bulged and forced off the hollow tile wall furring in spots.
